Case Report

The Case of the Broken Linx[®] System in a Sleeve Gastrectomy Patient

Abdelkader Hawasli*; Shoshana Hallowell

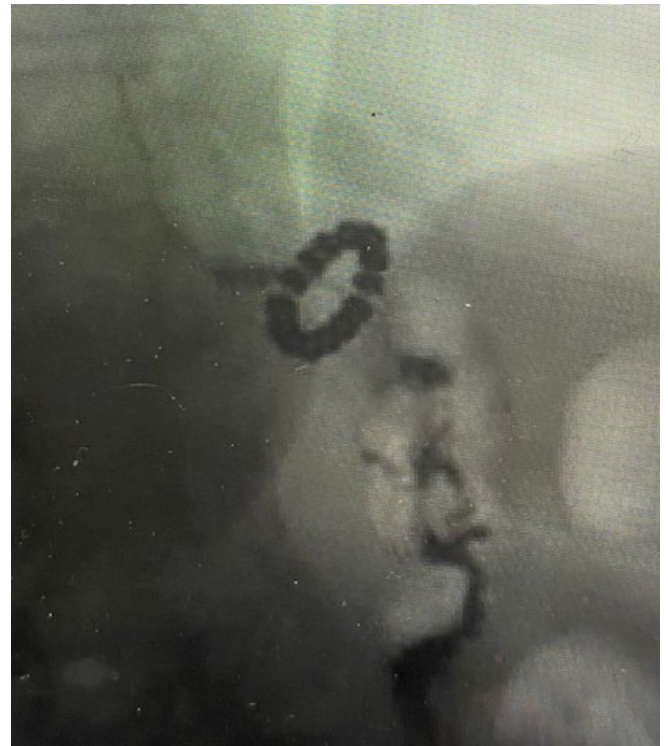
The patient declined the RYGB as an option to treat her reflux. She consented to having laparoscopic hiatal hernia repair and placement of the LINX® device which was done in November 2015 after IRB approval. The hiatal hernia was repaired around a 40-French bougie with posterior approximation of the crura with nonabsorbable sutures. A size 15 mm LINX® device was placed according to the company's instructions of using a device of 2 sizes above the esophageal size. The operative time was 65 minutes and there were no intraoperative or post operative complications. The patient did well post operatively. On post operative day one she underwent an UGI that revealed the device to be in good position with no reflux or hiatal hernia present (Figure 1).

Figure 1: Post-operative UGI November 2015.

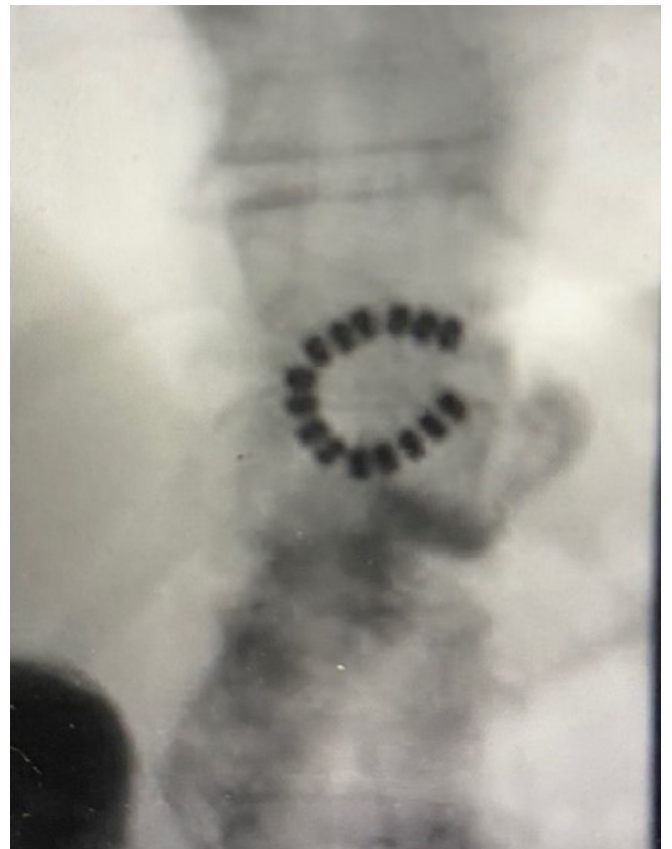
Figure 2: UGI showing LINX® device broken October 2021. The buckle is closed at 11 o'clock location with the break in the wire at 3 o'clock location.

We requested a repeat UGI, which was done in November 2021. The findings were negative for reflux or a hiatal hernia, however, the LINX® device was reported to be broken with evidence of a disconnected ring at the 3 o'clock location while the buckle was still closed. The device was no longer completely encircling the lower esophageal sphincter (Figure 2). A retrospective access to the patient's records from her other institution revealed chest X-rays from 2016 and 2018 which showed the LINX® device to be intact. The UGI which was done in September 2019, however, showed a break in the LINX® device, similar to the finding of November 2021 which unfortunately was not mentioned in the dictated report. In addition there was a chest X-ray in June 2021 which also showed the device to be broken but the radiologist did not address that in the dictated report as well (Figure 3). Since we became aware of this complication we were unable to schedule the patient for an EGD to evaluate her esophagus. She had cancelled multiple attempts to schedule her endoscopy due to transportation problem according to the patient.

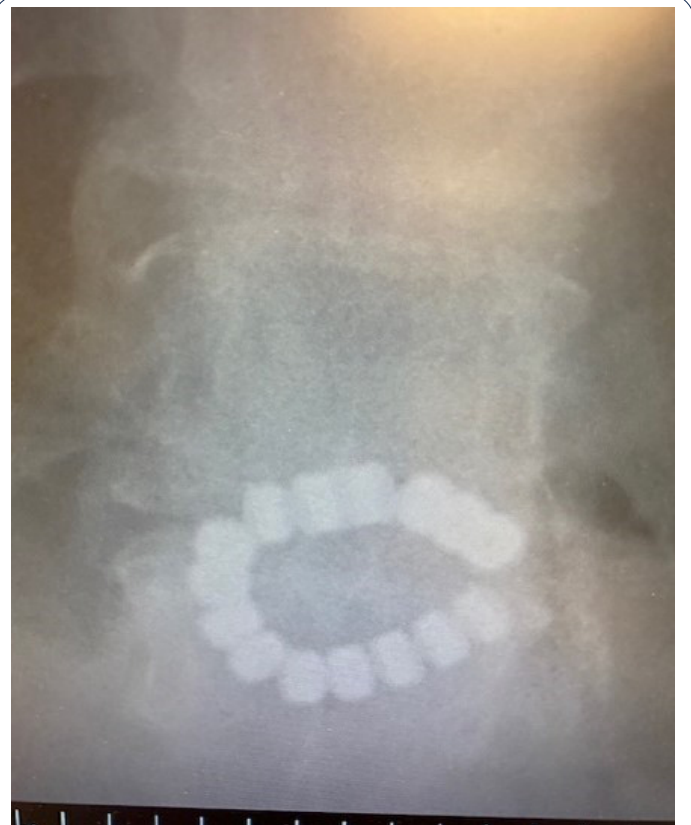
Figure 3: A chest X-ray June 2021 with evidence of a broken LINX®.

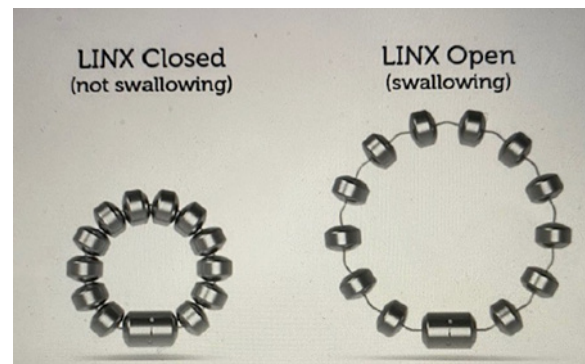
The mechanism of action of the LINX® is by providing augmentation to the lower esophageal sphincter by placement of magnetic beads configured in a flexible and expandable ring around the gastroesophageal junction. It consists of a series of titanium beads, each with a magnetic core, connected together with titanium wires to form a ring shape (Figure 4).

Figure 4: LINX® Reflux Management Device.
